# Studies on the behaviour of titanium activation foils during long-term exposure at the JET tokamak

## Abstract

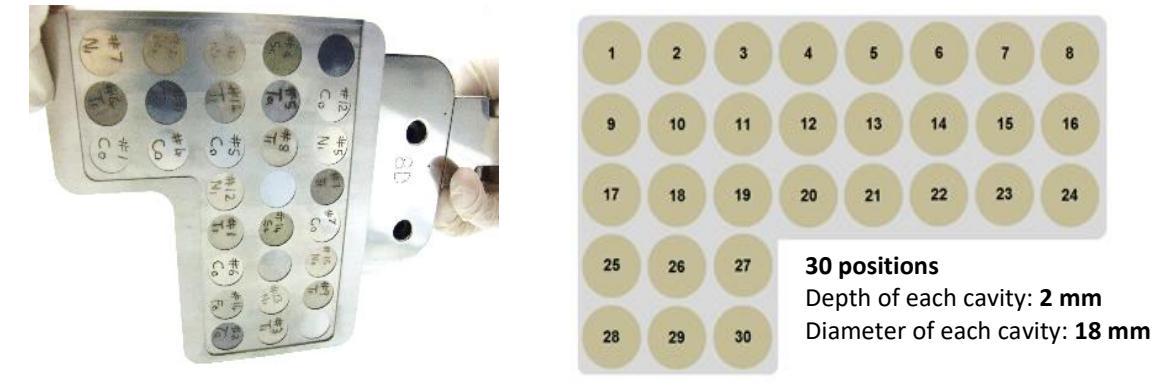
Fig.1 An image of the Long Term Irradiation Station with activation foils and the layout of the foils' positions inside LTIS.

The question was; what is the reason for the different behaviour of the Ti foils provided by CCFE, IFJ, and NCSRD. Looking at Table 1 and Fig.1 one can see that there was no major difference at least related to their location within LTIS. However, only one of the CCFE foils was in the positions where it was directly facing the plasma. This foil "survived" the irradiation. All of the other CCFE Ti foils were always between the IFJ samples and the Fe sample, which was the closest to the wall. Without fail, the foil's location inside LTIS would not explain why all the NCSRD and one of the CCFE Ti foils had deteriorated. Also on differences in the samples' thickness (IFJ Ti foils were 2 times thicker than the CCFE and NCSRD foils) cannot explain the fate of individual specimens.

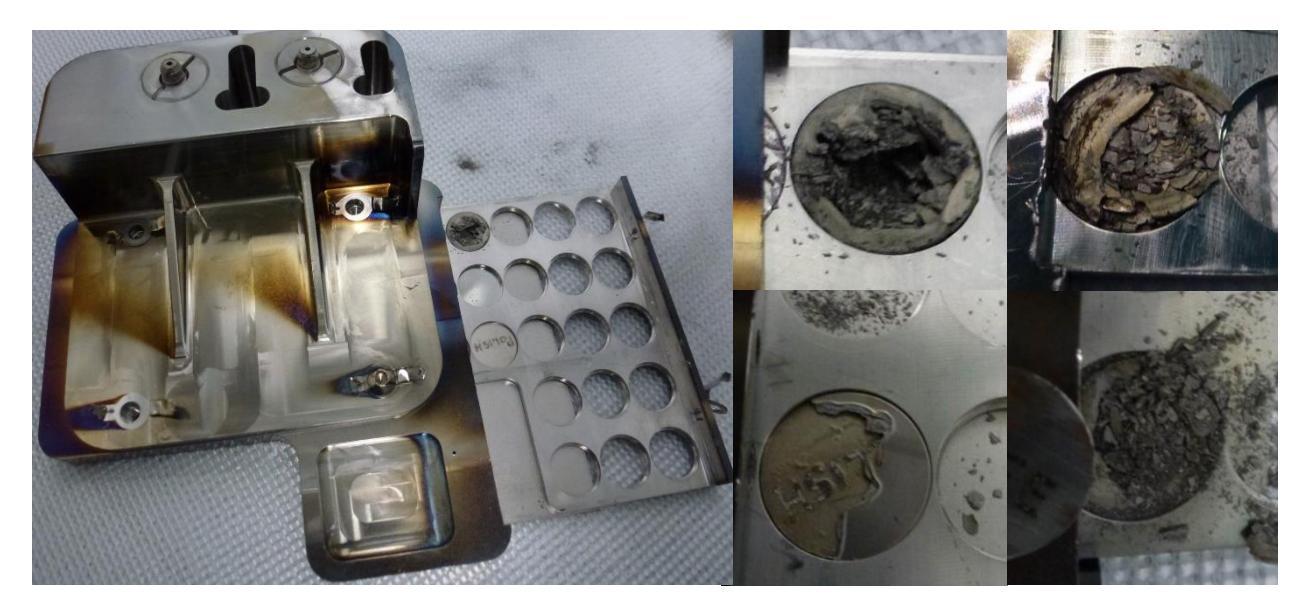
Fig.2. (right) LTIS assembly (back side) after removal from the JET tokamak; (left) appearance of the deteriorated Ti foils.

Following the end of the experimental campaign, the holders were removed from JET. The foils were retrieved from the assemblies in the Beryllium Handling Facility (BeHF) at JET, to assure that the samples were free of beryllium dust and radiological contamination assuring the safe shipment at laboratories involved in the project. The sample analysis consisting of gamma spectrometry measurements. During the foil retrieval process, it was found that some of the Ti foils had been

damaged, while several others were totally or partly deteriorated. Most of the pure Ti disk-shaped foils with a thickness of 0.5 mm turned into a dark grey powder. Data in Table 1 provide information about respective foils inside the assemblies and about the damage to some Ti specimens. Foil layers 1 - 4 at each cavity are denoted by F1 - F4 with F1 being closest to the plasma and F4 closest to the vacuum vessel's wall. The positions 1 - 30 are as in Fig.1. The deteriorated Ti foils were in positions #4 at 4D and 8D, #11 at 4D and #29 at 4D and 8D. These were all the ten foils provided by NCSRD and one foil from CCFE. Fig. 2 shows some pictures of one of the LTIS assembly and the foils which deteriorated during the campaign. Among nine Ti foils provided by IFJ, two foils, located in the position #11 8D and #7 4D, were slightly damaged at the edge (see Fig.3).

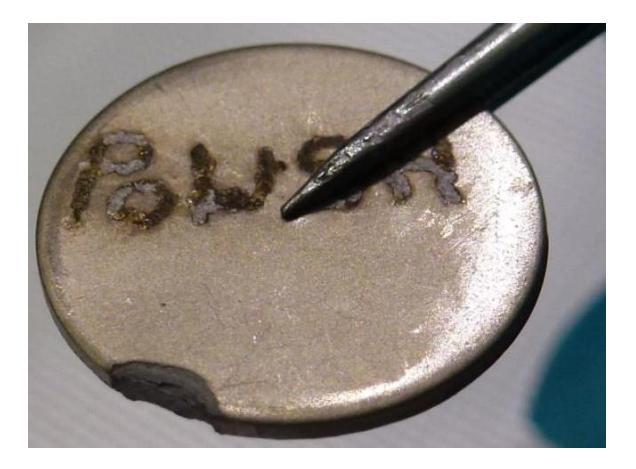
Fig.3. Images of the Ti foil (ID #11 8D) provided by IFJ PAN (held with tweezers). The foil was only slightly damaged at the edge. The foil unique ID (not visible here) and the name of the country which provided the foil was etched prior to irradiation.

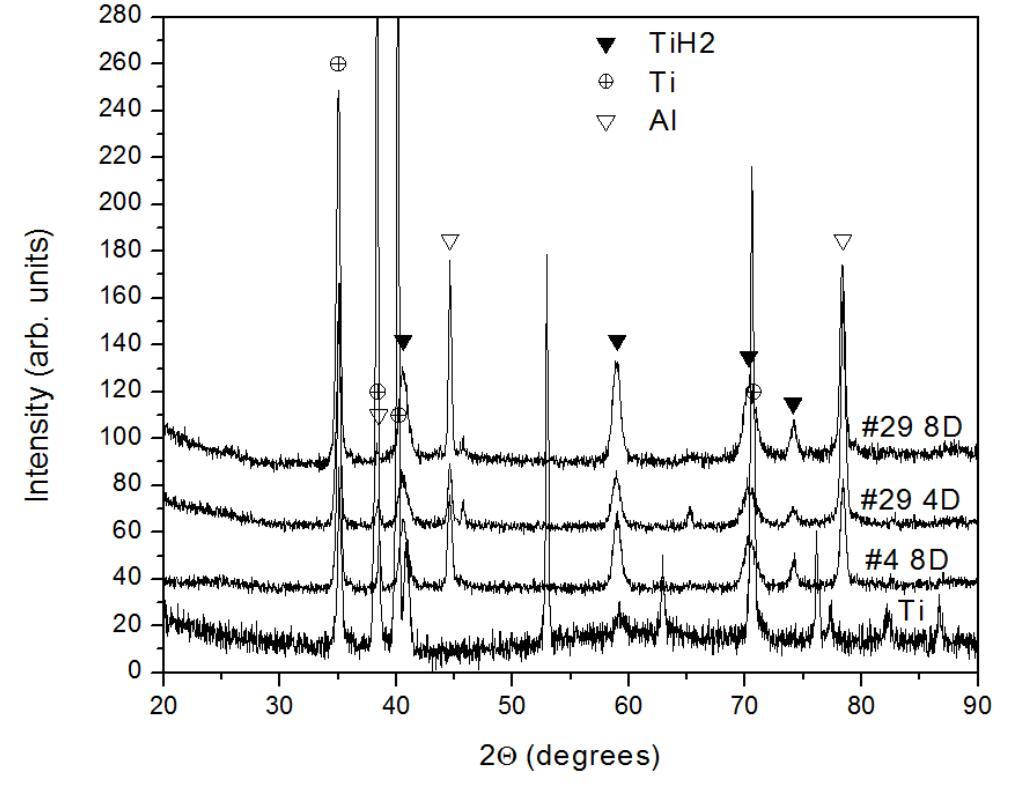
The XR diffractograms for three NCSRD foils and a reference diffractogram of a non-irradiated Ti foil are shown in Fig. 4. The measurements of the deteriorated Ti foils #4 8D, #29 4D and #29 8D confirmed the formation of  $TiH_2$ .

However, not all Ti has been transformed into  $TiH_2$ . Due to the non-homogeneous powder thickness of the flakes, the quantification of the amount of Ti transformed into  $TiH_2$ , was not performed since it might have led to erroneous results.

Fig. 4. XRD patterns of the deteriorated NCSRD Ti foils irradiated in LTIS at positions #4 8D, #29 4D and #29 8D. As a reference, a signal from the non-irradiated sample is shown. Al Bragg peaks are due to the aluminium stub on top of which the damaged Ti flakes were stuck.

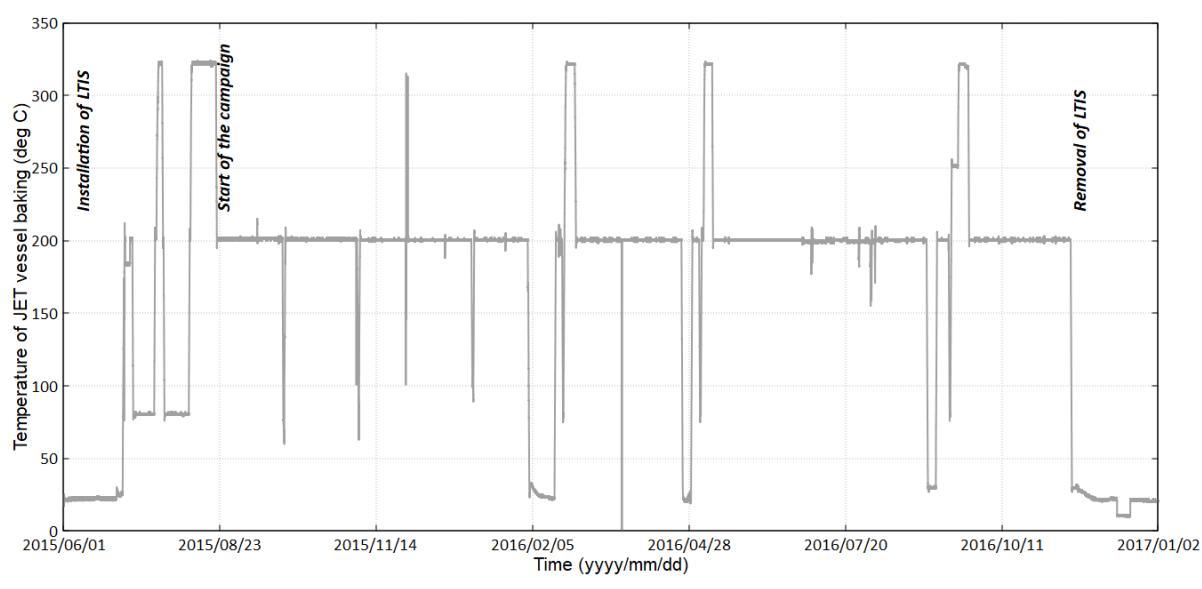
Tracing back details of the baking sequence of the JET vessel during the 2015-2016 D-D campaign (Fig.5), a hypothesis can be formulated that the formation of TiH<sub>2</sub> could occur even before the irradiation period began. Baking of a vacuum vessel is a standard procedure accompanying not only the pump-down after vessel venting but the elevated wall temperature is maintained during the entire experimental campaign. The vessel is heated to a certain temperature to desorb impurities, to achieve a better vacuum during the experiment. In general, the process consists of a few stages. The first one is to pump down the vessel to rough vacuum and bake it at about 200 °C with the water-cooled elements drained to remove impurities. Once the pressure starts to drop, and so does the temperature, the vessel is again heated up to 80 °C and water is pumped into the water cooling system. The vessel is then baked to 320 °C for a couple of cycles, whereas, during plasma operations, the vessel is usually kept at around 200 °C. Due to the diverse problems on JET during the 2015-16 campaign, there were multiple bake-out throughout the operation. There is also the possibility that the desorption of hydrogen from the JET walls during the bake-out phase could lead to a reaction with Ti and thus to the formation of TiH<sub>2</sub>.

Fig.5. The baking scenario of the JET vacuum vessel during the 2015-2016 D-D campaign.

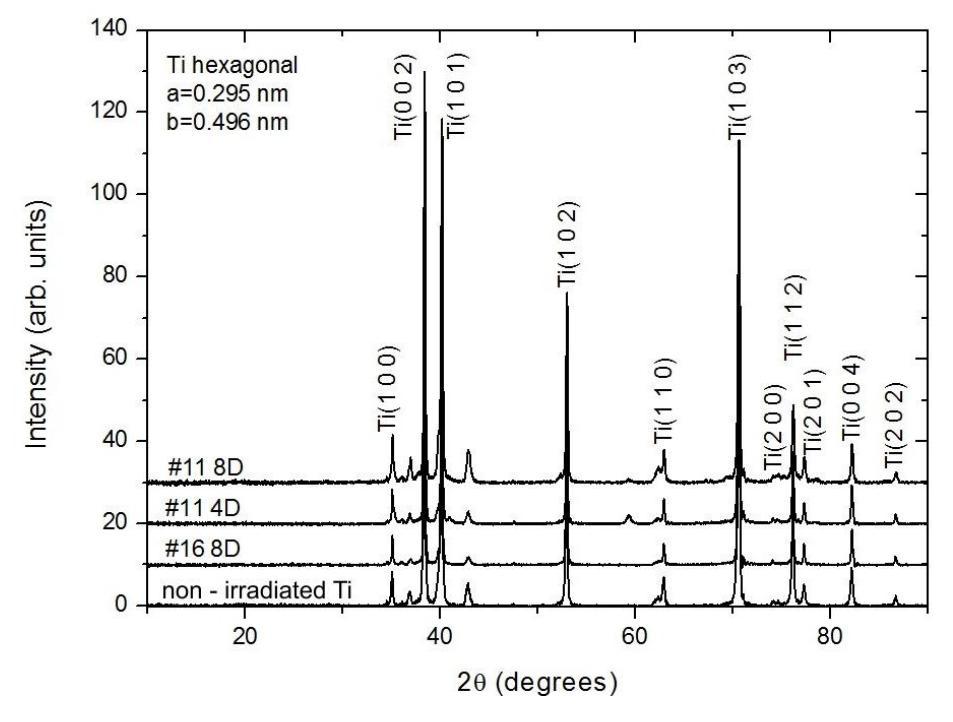
However, not all Ti foils turned into a grey powder (TiH<sub>2</sub>). For all the surviving Ti samples, the XRD measurements revealed only a set of intense reflections from pure titanium with no diffraction peaks for TiH<sub>2</sub>. The XRD patterns, collected for the irradiated (located at LTIS positions #11 4D, #11 8D and #16 8D) and non-irradiated IFJ Ti samples are presented in Fig. 7. The background and the input from Cu K $\alpha$ 2 radiation were subtracted so that only the signal from the K $\alpha$ 1 line would remain. The intensities of the reflections vary slightly from sample to sample (see Fig.6). The location of the observed reflections and their intensity does not change significantly from sample to sample. It was hard to match these peak profiles with any specific element or compound at this stage of research. Since non-stoichiometric compounds, which composition varies continuously do not give rise to X-ray diffraction peaks, the presence of some phases (or one phase) of a non-stoichiometric titanium oxide could not have been completely eliminated.

Fig. 6. XRD patterns of IFJ Ti samples irradiated in LTIS at positions #11 4D, #11 8D and #16 8D. As a reference, a signal from the non-irradiated sample is shown.

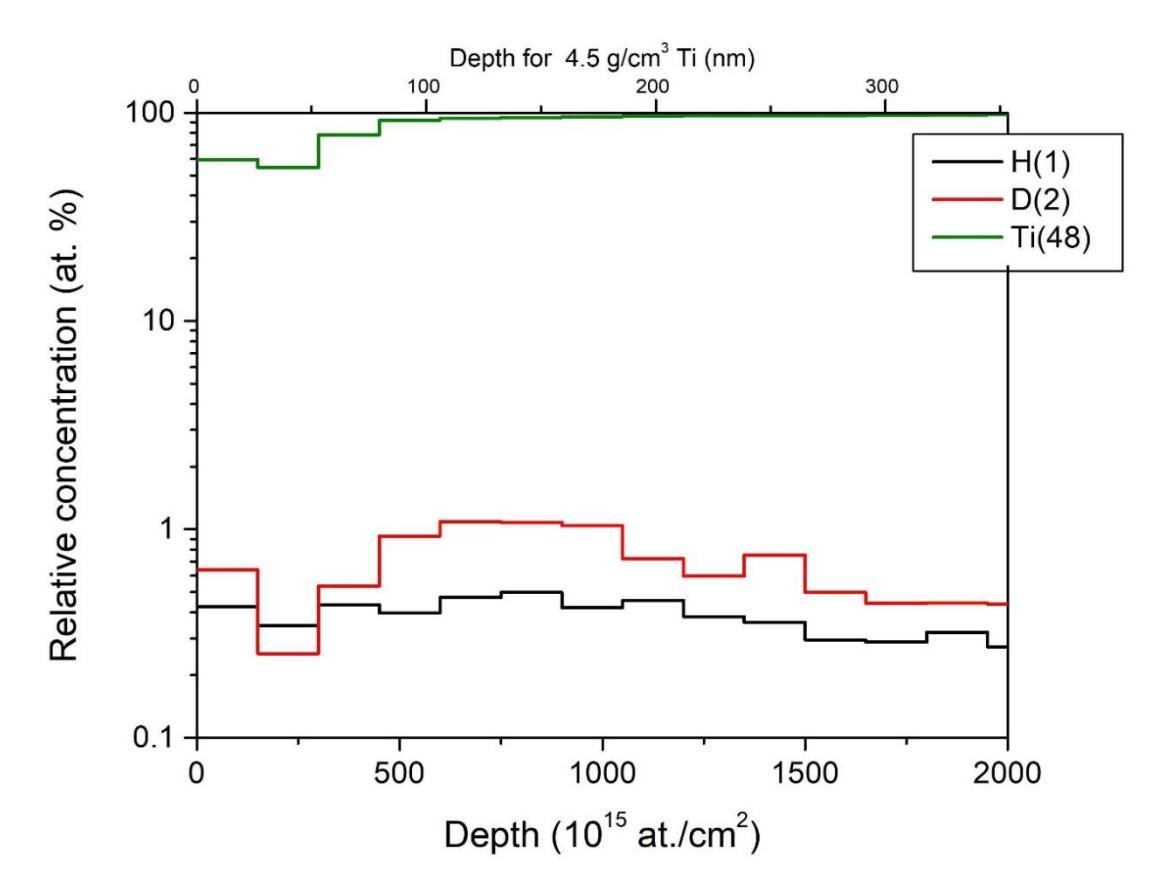
Since the PIXE method is not sensitive to light elements, additional ToF-ERDA measurements were performed to determine the surface composition of the damaged IFJ Ti activation sample #11 8D. ERDA is the only method for quantitative depth profiling of the surface layer up to 600-700 nm. Depth profiles of several detected elements are presented in Fig. 7 and 8, showing respectively hydrogen isotopes and heavier species in the titanium substrates. The primary depth scale is given as the total amount of atoms/cm<sup>2</sup>, which is a natural depth scale for ion beam analysis as it cannot measure depth, but rather how many atoms the ions have passed while travelling through the sample. This depth scale can be converted to nm if the density of atoms is either known or assumed. In the top scale, the conversion was done assuming the density of Ti (4.5 g/cm<sup>3</sup>) to help interpret the depth scale. The use of at/cm<sup>2</sup> as a depth scale also means that a relative concentration in (at. %) for a given depth becomes natural. It does, however, mean that the depth scale in nm becomes unreliable if there are any fluctuations in density or even in the concentration of the elements. The total content of hydrogen isotopes (Fig. 7) in the analysed surface layer does not exceed 2 %. As shown in Fig. 8, oxygen is the dominant impurity species on the surface. The concentration ratio Ti:O approaches 1. The content of other elements such as carbon, nitrogen and metals does not exceed 2 atomic %. Iron stands here for steel and Inconel components eroded by plasma from the JET wall and the foil holder itself. This surface composition with mixed light and heavier species is typical for surfaces exposed to plasma in the scrape-off layer. Only the high oxygen content strongly indicates the titanium oxidation upon the foil exposure to air. Other species, e.g. F, Na, occurring only in the very surface in minute quantities (0.1-0.8%) are not discussed here because their presence is related rather to sample handling in one of laboratories than to exposure in JET.

Fig. 7. ToF-ERDA depth profile of IFJ Ti sample damaged during the irradiations at the JET tokamak. Only the hydrogen isotopes and Ti are shown.

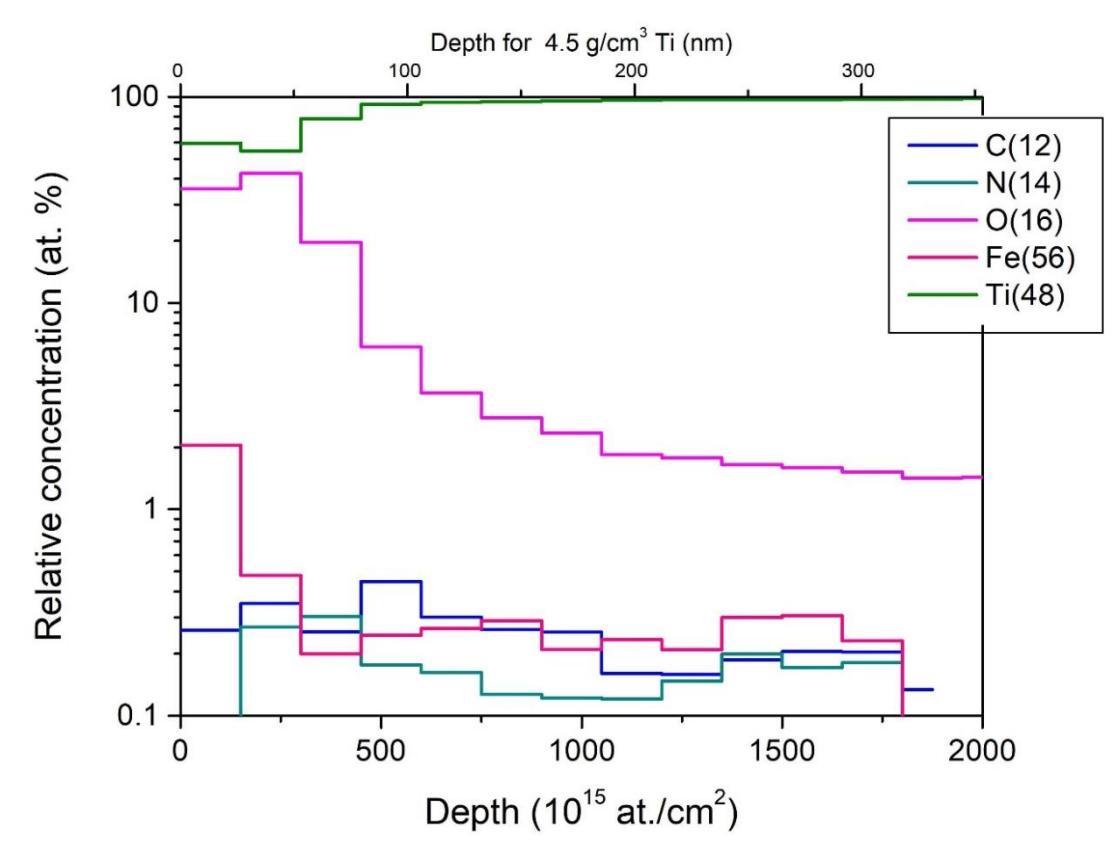
Fig. 8. ToF-ERDA depth profile of IFJ Ti sample #11 8D damaged during the irradiations at the JET tokamak. Only the elements with a mass number of 12 (C), 14 (N), 16 (O), 48 (Ti) and Fe(56) are shown.

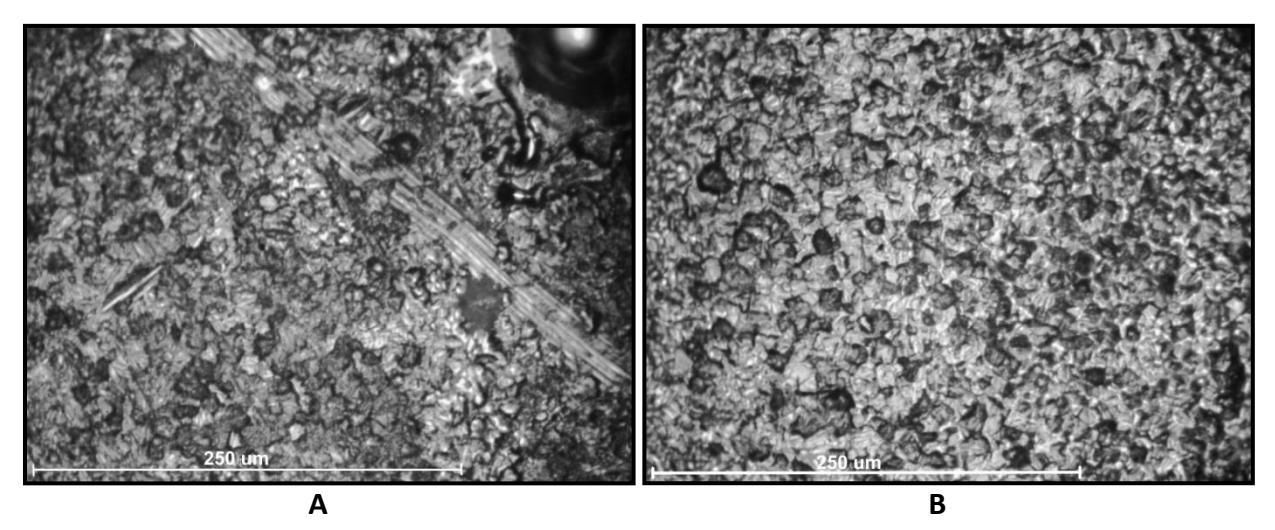
As none of the samples had been mirror-polished, grains were protruding and well visible on the rough surface. When the micrographs were taken and the samples analyzed, not many differences were observable neither on the samples nor their different sides. In Figure 9 is shown a selection of images with equal enlargements of two different samples with various characteristics that are apparent on all of the samples. In panel A of Fig. 9. is an image of grains in the sample irradiated in LTIS at position #7 4D. The picture has been captured near the damaged area. Panel B shows the control (non-irradiated) sample.

In general, the grain sizes do not differ from sample to sample, but on each of the samples, there are regions where the grain sizes either differ or the distinction between grains is difficult. This is apparent for example, in panel A of Fig. 9. in the vicinity of the etchings – the heating while etching has interfered with the structure of the material, apparently inducing recrystallization of the grained structure.

Fig. 9. In general, all of the samples look the same on both sides. A) sample #7 4D near the damaged section – damage is visible on the upper right corner; B) the surface of the control (non-irradiated) IFJ sample.

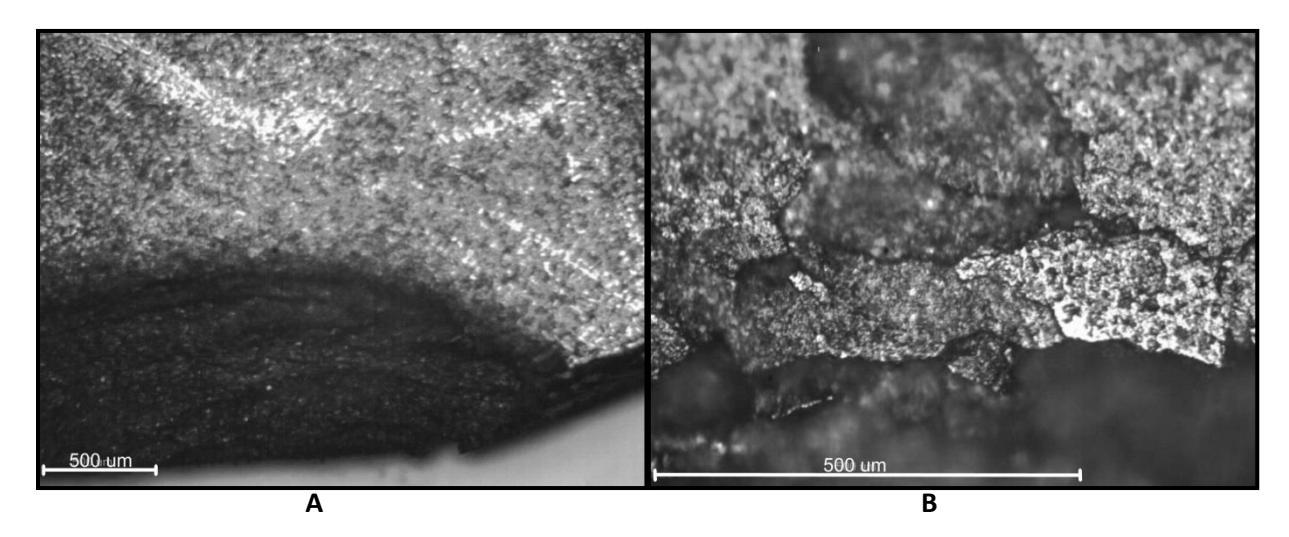
Figure 10 shows close-up of the damaged edge of sample ID #7 4D. The immediate origin of the damage is unknown. As we were not to use invasive methods that might damage the sample, we could not either confirm or contradict the possibility of the sample being damaged due to the formation of Titanium(II)Hydride.

The damaged area (in Fig. 10 panel A) is discoloured compared to the rest of the sample to the naked eye. The samples' microscopic analysis indicates that the dark substance on the sample's damaged area has broken off in small fragments, layer after layer, resulting in the damages to have a flake-like structure. Hydrogen is known to induce embrittlement in Ti and the spalling is known to occur due to the embrittlement; it is possible that the damages have occurred due to the formation of TiH<sub>2</sub>.

Fig. 10. The damaged area of sample #7 4D: A) erosion; B) close-up of the flake-like structure of the damage.

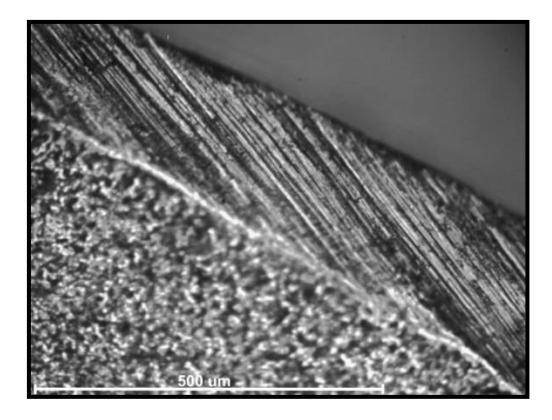
While analysing the damages, also the side of the sample #7 4D was investigated. The even and parallel straight lines in Fig. 11 suggest the IFJ samples also have been cut out of a sheet, most likely without heating the material but rather by mechanical cutting, perhaps punch-cutting.

Fig. 11. The edge of IFJ sample #7 4D indicates cutting.

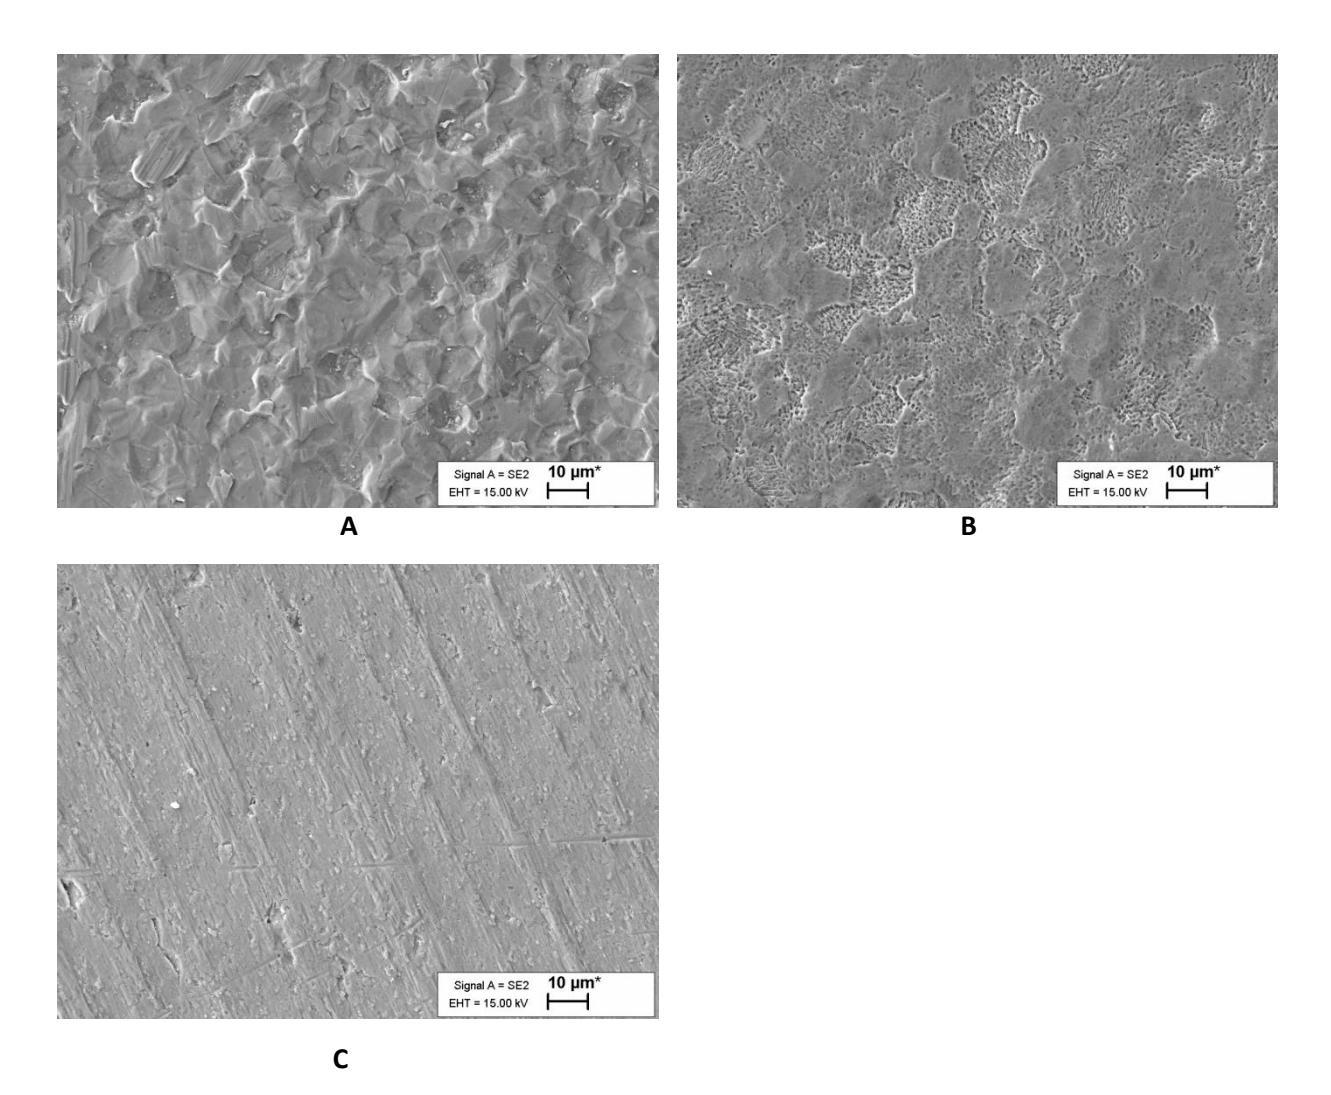
SEM imaging was conducted for the selected samples, to obtain more information on the materials. Among them were: one irradiated IFJ sample #7 4D; two non-irradiated NCSRD samples and two CCFE samples irradiated in the LTIS positions #18 8D (F1 and F2). As the materials' production method and the samples' surface treatment had not been provided, at first a comparison of the representative areas of the surfaces was conducted (see Fig. 12). The results indicate that the materials have been with different surface structures from the very beginning and the irradiation has not altered them too much. It also suggests the difference in the initial grain structure from the samples manufacturing process such as e.g. rolling.

Fig. 12. Comparison of the SEM analysis of the representative surfaces of different samples, with equal magnifications: A) an irradiated IFJ sample, #7 4D; B) a non-irradiated NCSRD sample (referred to as GC#1); C) an irradiated CCFE sample, #18 8D (F1).

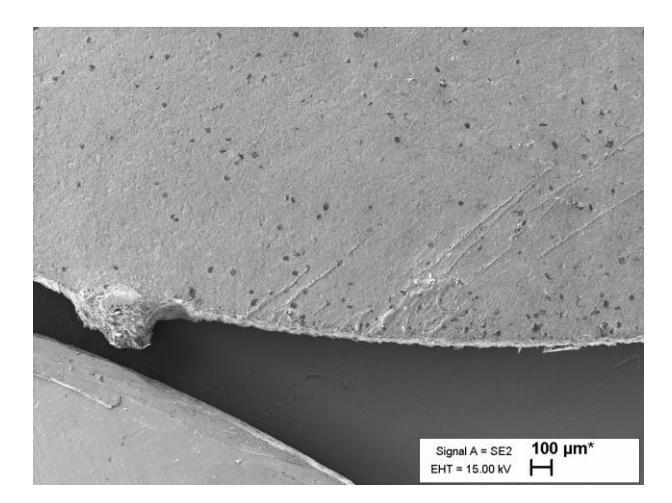
The non-irradiated NCSRD samples that had been "cut out and deburred" before the SEM analysis are the same type of material that all got deteriorated within JET. The analysis of the edge of one of these samples (referred to as GC#2) indicated that laser cutting caused the formation of a burr, both on the cut foil and also on the Ti sheet, where it was cut from. Interestingly the samples should not have had a burr during the SEM imaging, as the burrs were supposedly removed. Nevertheless, the burr on the foil is visible on the left-hand side in Fig. 13. Even with this magnification, the cut's uneven edge is visible and the possibility of the existence of the micro-cracks is present. These kinds of burrs are not necessarily well-visible to the naked eye.

Fig. 13. Burr on the laser cut NCSRD Ti foil GC#2.

Quite a different story could be true for samples with burrs on the samples edges – near a burr the oxide layer might not necessarily be with a constant thickness or with a complete coverage. This might enable to speed the diffusion of H to Ti and lead to their reaction. The diffusion could also happen faster and with more ease on samples that have received thermo-mechanical damages during cutting. The rapid heating and cooling might have induced the formation of micro-cracks on the edges of the laser cut samples. The cracks could be convenient passage-ways for the diffusing H, once again leading to a reaction. This might be the reason why NCSRD's samples were deteriorated.

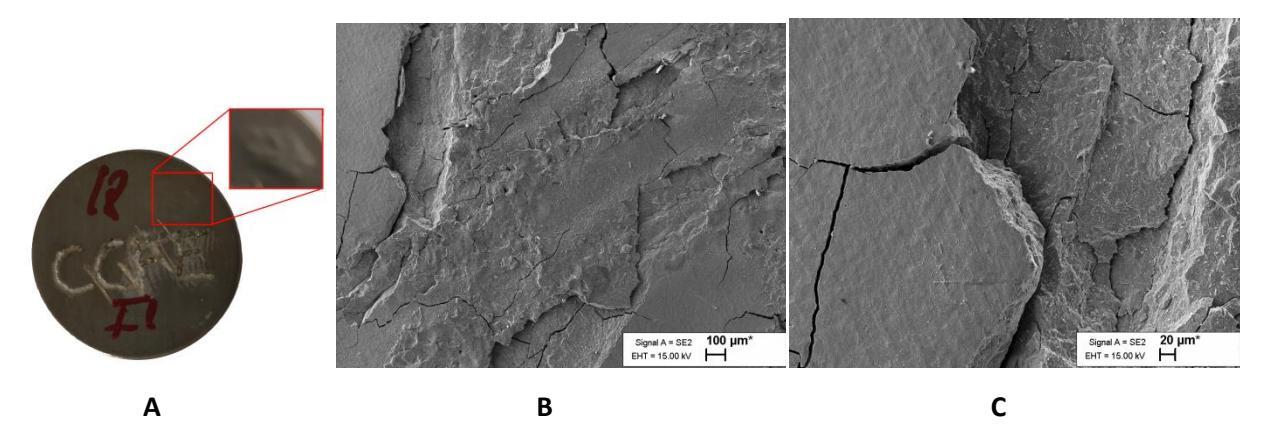
The CCFE samples' random characteristic surfaces look almost identical. Interestingly on the sample #18 8D F1 there was unexpected damage on the sample's surface, quite far from the sample's edge. Fig. 14. shows the damaged area on the sample and also magnifications of the damaged area. The damaged area is not well visible to the naked eye, but the SEM images indicate an area where strong cracking and erosion of material have taken place. Slight damages were also observed in IFJ plasma facing foils (F1 - when considering their sequence of distribution within the particular LTIS cavities, thus such damage is expected). What has induced such damages, remains not fully understood.

Fig. 14. Sample #18 8D F1 with a damage on the sample's surface: A) location of the damaged area, a combination of two photographs; B) magnification of the damaged area; C) a close up of the left-hand side of the panel B.

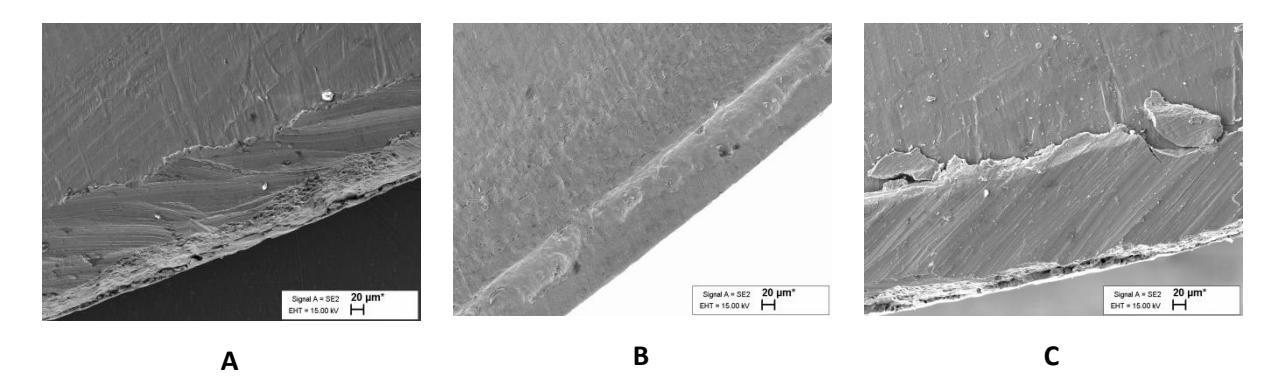
For comparison also Fig.15 has been compiled, of the different SEM images of the edges of the samples that have not yet been presented. The edge of foil #18 8D F1, on panel A, seems somewhat damaged, with a cellular structure. The least deteriorated of the three, is foil #18 8D F2, on panel B, with a nice clean edge. The strongly deteriorated sample #11 4D, on panel C, has an edge where flaking is apparent and seems that there has already been some erosion taking place, as well.

Fig.15. Some edges of the samples and their micro-structures: A) The edge of sample #18 8D F1, with it's cellular surface structures; B) clean edge of sample #18 8D F2; C) micro-structures and cracking on the sample #11 4D.
